Generation
II™

SONCELL NORTH AMERICA
A PUBLIC SAFETY COMPANY

SUPPLEMENTAL INSTRUCTION SHEET FOR RETROFITTING NEWER GEN II MODULES INTO EXISTING INSTALLATIONS

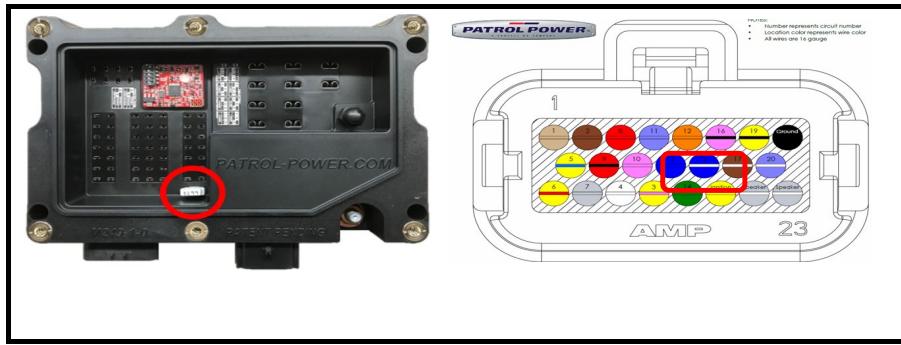
OLDER MODULE IDENTIFYING ATTENUATOR LOCATION & CONNECTOR

We have ceased production GEN II fuse blocks that featured the siren attenuator. The new fuse block has been designed to be backwards compatible with existing installations with the exception of the aforementioned attenuator circuit.

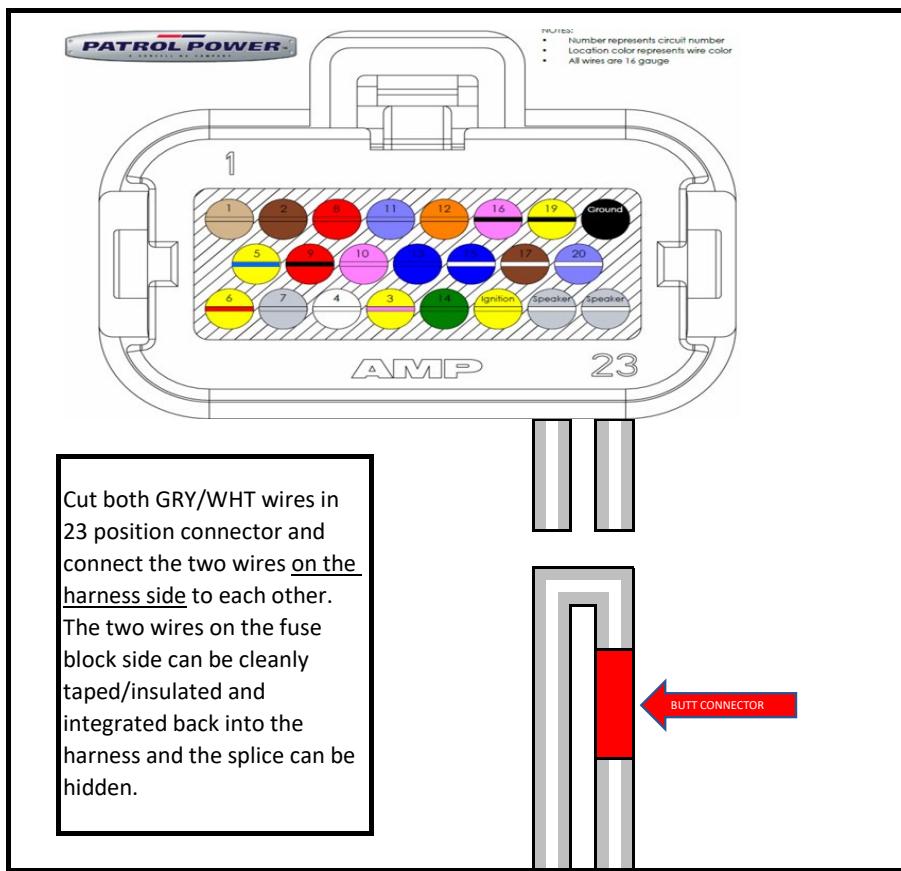
HARNESS MODIFICATION REQUIRED IF ATTENUATOR IS BEING USED

Older fuse panels with the attenuator circuit are clearly identifiable by the attenuator position in the lower, center fuse portion of the fuse block and by the presence of two GRY/WHT wires in the harness (pins 22 & 23 of the 23 pin connector). The wire harness will need to be modified, but only if the siren attenuator loop is being utilized in the vehicle. If the siren attenuator loop is not being utilized, no further modifications will be necessary. If you aren't sure if the siren attenuator is being used, there are a few ways to determine this.

- 1) Is there a fuse or a resistor in the siren attenuator location in the fuse block? If there's a diode or nothing, the attenuator loop isn't being used.
- 2) If the attenuator location has a fuse in it, remove the fuse. If the siren speaker still functions, the attenuator loop isn't being used. If it stops functioning, the attenuator loop is being used and you will need to connect the two GRY/WHT wires to each other on the harness side, not the fuse block side. Refer to diagram to right.
